Imaging and Information Processing of Pitting-Corroded Aluminum Alloy Panels with Surface Metrology Methods

In this paper, we take advantage of both contact and non-contact surface metrology techniques to obtain 2D and 3D images/profiles for accurate characterization of pitting corrosion attack in AA7075-T6 aluminum alloy panels; extract and select promising morphologic and texture

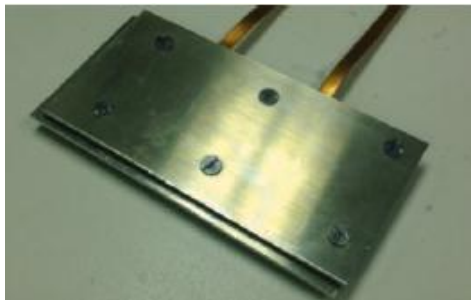
Figure 2. AA7075-T6 and AA2024-T3 lap joint assembly.
